**MARINE INVESTIGATION REPORT
M15C0028**

**GROUNDING
BULK CARRIER *CWB MARQUIS*
BEAUHARNOIS, QUEBEC
03 APRIL 2015**

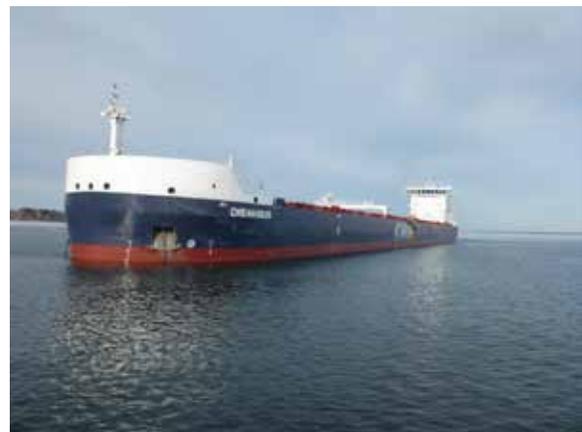
Photo 1. *CWB Marquis*

The *CWB Marquis* (Photo 1) is a dry bulk cargo vessel with 5 cargo holds. The machinery and accommodation spaces are located aft. Propulsion is provided by 1 five-cylinder diesel engine driving a controllable-pitch propeller. Electrical power is supplied by 3 generators, as well as an emergency generator. The vessel is fitted with a 1200 kW bow thruster situated in an enclosed space within the forepeak compartment. The vessel has 3 anchors: 2 forward and 1 at the stern.

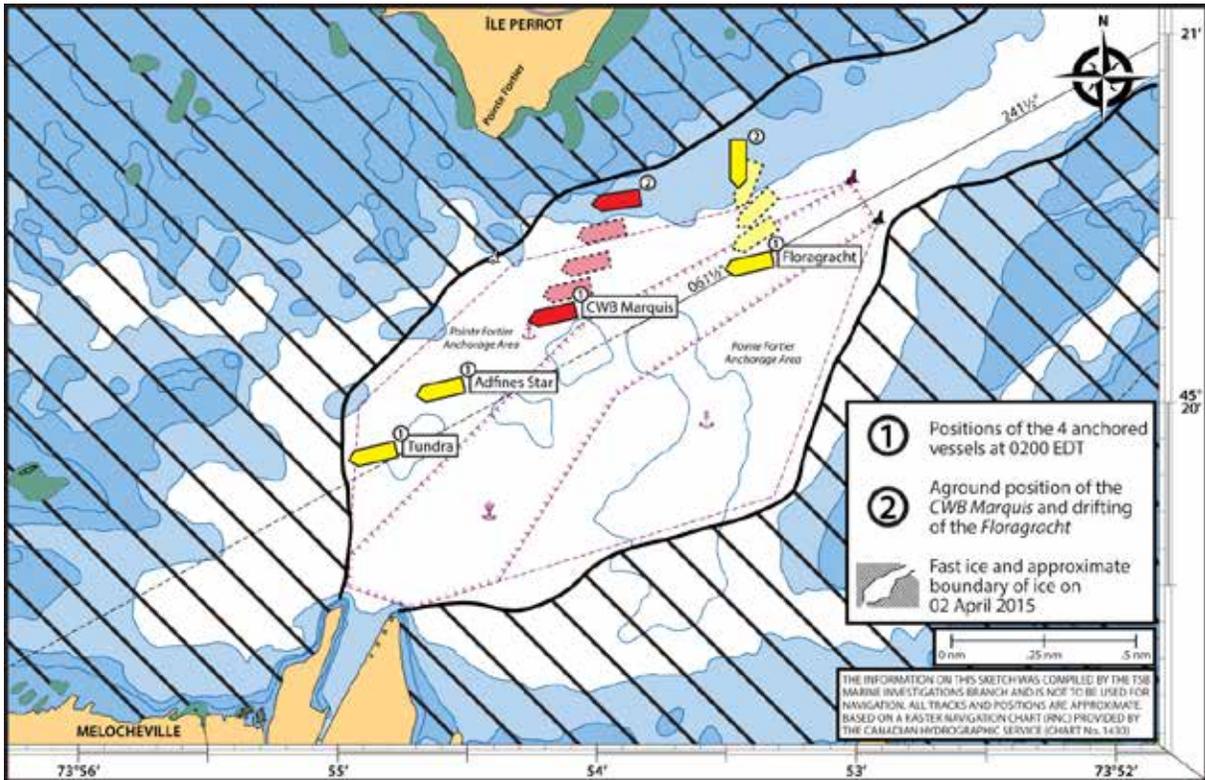
Appendix C – Area of occurrence (with vessel movement)

The *Tundra* arrived at 2051 and anchored 0.9 nm south-southwest of Pointe Fortier, closer to the entrance of the Lower Beauharnois lock. The *Floragracht* arrived at 2157 and dropped anchor in the navigation channel, 0.75 nm east-southeast of Pointe Fortier (Appendix C).
