SAFETY INVESTIGATION REPORT

REPORT NO.: 08/2016

May 2016

MV Kadri Fatal injury to a crew member at Tallinn Shipyard 19 May 2015

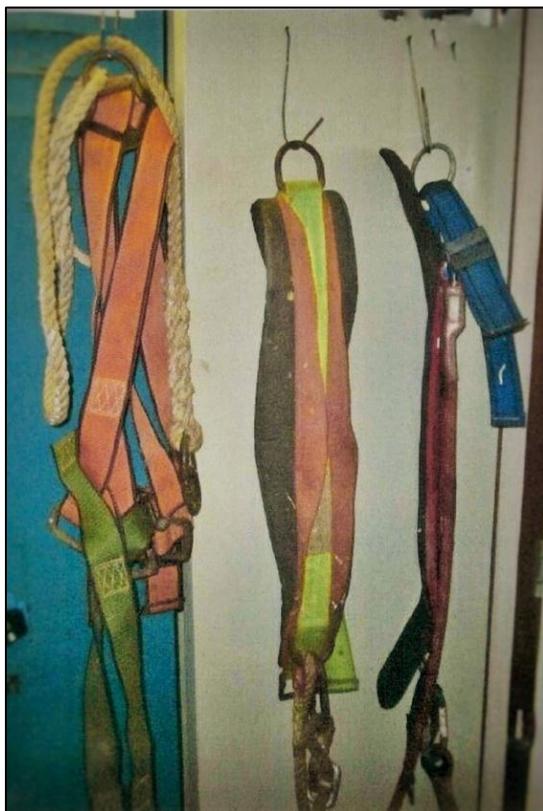
Figure 2: Safety harness and fall arrestor device.

On 30 April 2015, a safety meeting was held by the master and all crew members were instructed on safety, SMS procedures and safe working practices. Work planned for the crew at the shipyard was also reviewed. Personal protective equipment was checked and risks to crew working on deck were assessed. The hatch covers were cleared of obstructions and an 8 mm galvanised steel safety line above the hatch coaming was fitted for use by the crew with safety harness and fall arrestor device (Figure 2).

4. The able seaman was not wearing a safety harness with a fall arrestor device attached to the safety line.
5. The risk of falling overboard had been accepted by the crew member.

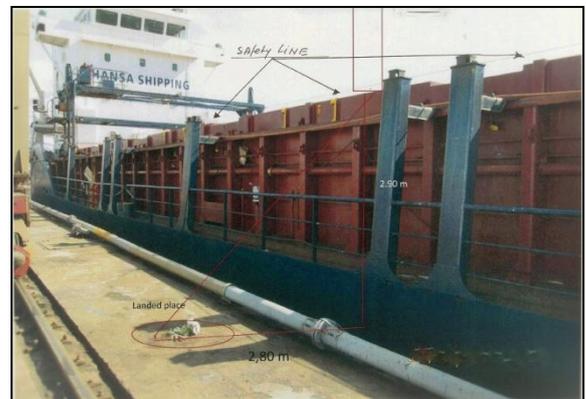
It therefore appears that the able seaman acted on his own accord. Even more, no one recalled either seeing him on the cargo hatch cover or falling over². Nonetheless the serious injuries suffered by the able seaman were comparable with that of a fall from a height. The photographs submitted by the vessel indicated a fall of about three metres from the hatch cover/coaming (Figure 3).

Figure 3: Area of the accident and approximate position of the area where the AB landed

Considering that no credible evidence was available to the MSIU, the safety investigation did not exclude the possibility of the able seaman standing on the ship's rails in order to reach for the cleats. It was considered probable that his movements, whether standing near the edge of the hatch cover or on the ship's rails, faltered, lost his footing and fell down on the hard surface of the quay. The able seaman was not wearing a safety harness with a fall arrestor device attached to the safety line.

- A Company Circular on the risk of crew member injuries was issued and circulated to all vessels, requesting a discussion among crew members. An extraordinary briefing / training on safety at work was also requested, focusing mainly on the Code of Safe Working Practice for Merchant Seamen and the Company's SMS procedures. It was also required that special attention had to be paid to crew members working at a height, workplace arrangements and personal protective equipment;
