SIMPLIFIED SAFETY INVESTIGATION REPORT

REPORT NO.: 16/2016

MV MARIBELLA **Engine-room fire** **In position 34° 49' N 122° 58' W** **27 July 2015**

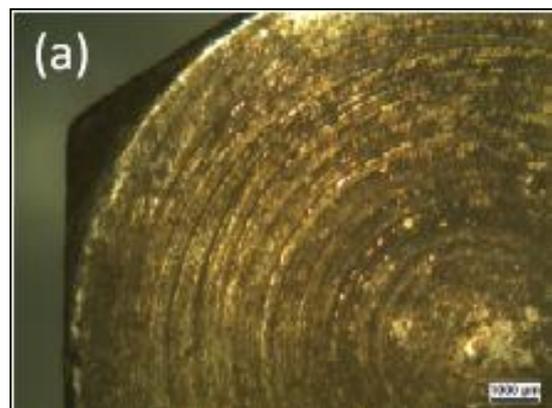
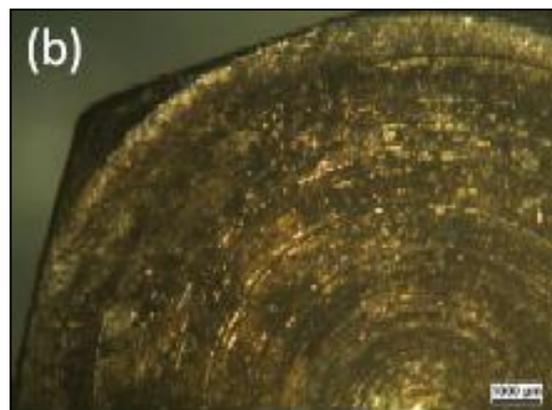
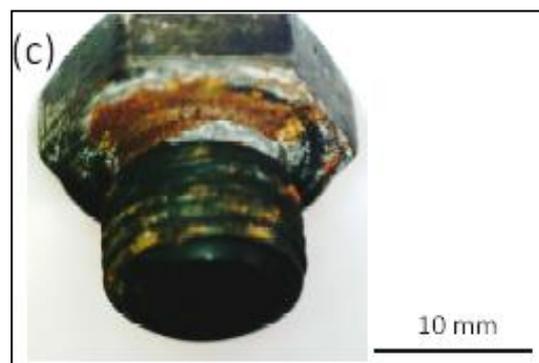
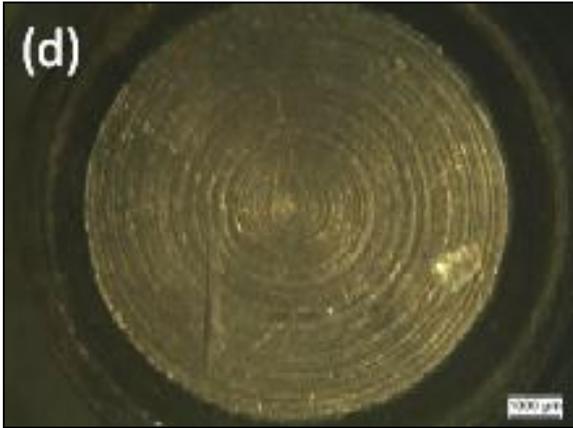
No significant damage beyond minor signs of corrosion were identified (Figures 1a to 1d).

Figures 1a to 1d: Stereomicrographs of the bolt plug head/top and point surface

The microscopy examination suggested that the bolt had not been damaged. Moreover, it was considered unlikely that the plug would have come loose had it been appropriately tightened. The bolt neither showed signs of previous over-torquing nor any other damage. To this effect, it was deduced that the bolt should have maintained tension following its (proper) installation.

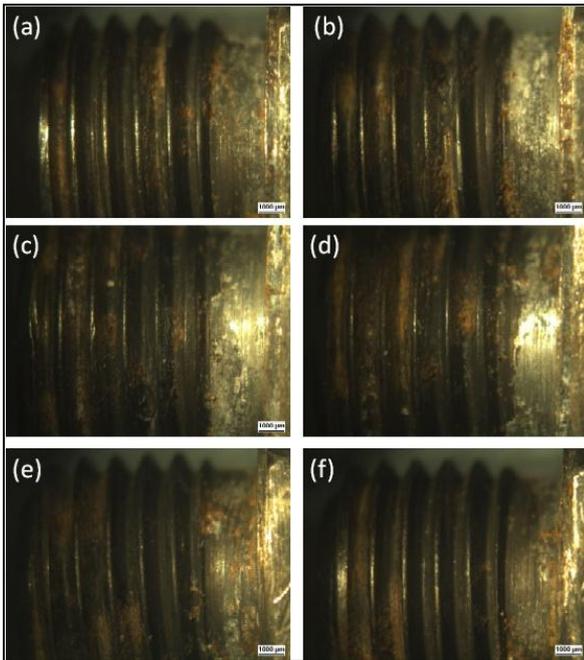
Moreover, no damage, stripping, surface cracking and deformation of the thread were identified at the set magnification (Figures 2a to 2f).

Figures 2a to 2f: Bolt thread at each of the six facets of the plug

The absence of damage on the bolt’s thread also suggested that anomalous operation of the pump (say, overpressure) did not cause the failure. It was therefore reasonable to attribute failure to spontaneous bolt loosening from, either:

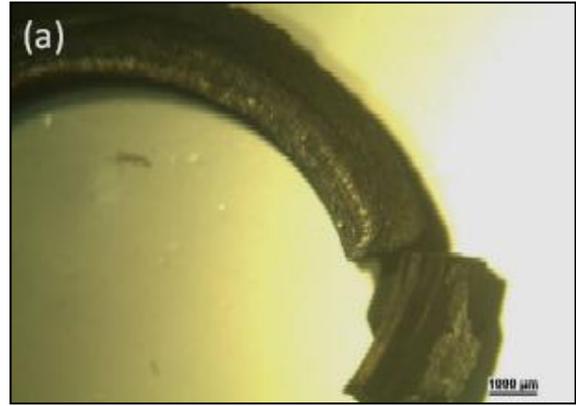
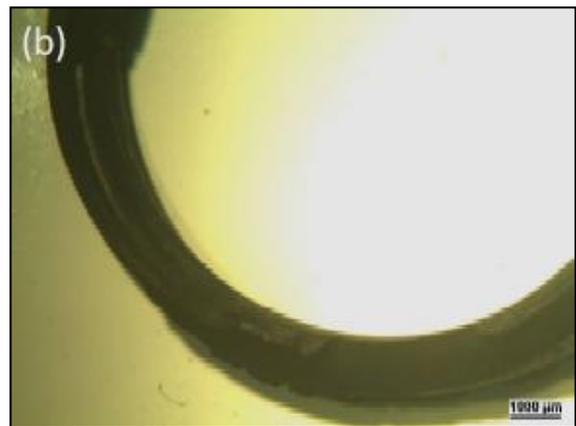
The metallic washer, however, was found severely damaged, cracked and extensively deformed. It appeared brittle and was fragmented into four sections (Figures 3a and 3b). It is known that the hardening of copper washers usually occurs during ‘crushing’, in this case, between the bolt and the pump housing.

Figures 3a and 3b: Micrographs of the metallic washer

- ii. the metallic washer installed during the final bolt assembly prior to the eventual failure had already been significantly deformed and damaged from prior use. This soon deteriorated allowing for premature loosening. The brittle state of the washer suggested that this may have been re-used, possibly multiple times. Once the washer fractured, the bolt would have easily loosened up due to the normal vibrations during the operation of the pump and the engine.

The safety investigation was unable to conclude with absolute certainty the psychological origin of the actions taken when the fuel oil injection pump was boxed up again. However, considering that the technical analysis revealed a brittle metallic washer, it was considered more plausible that there was never the intention to replace the old metallic washer during the assembly of the pump.

16/2016_R2 issue a Fleet Circular prohibiting the re-use of metallic washers and emphasise the importance of correct tightening procedures on installed equipment and machinery.
