SIMPLIFIED SAFETY INVESTIGATION REPORT

REPORT NO.: 13/2016

MV NORTH SEA ATLANTIC

Serious injury to crew member

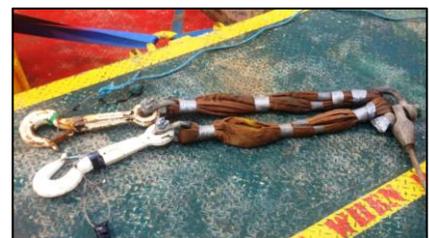
The associated rigging arrangement included a two leg bridal gear (Figure 1), connected to the clump weight. The hook-ends were fastened with messenger lines to remotely operate/open the hooks.

Figure 1: Two leg bridal gear with remotely operated hooks

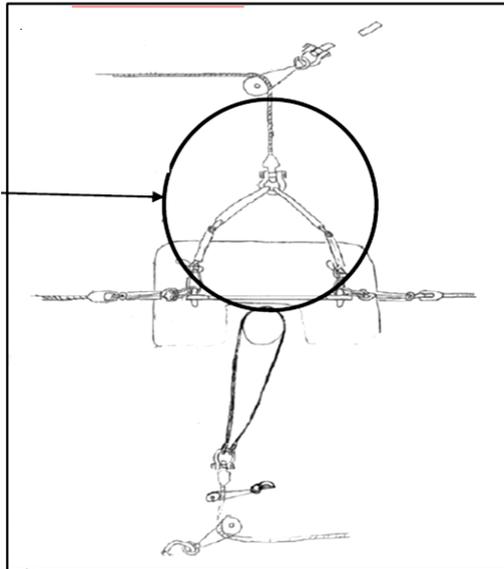
Each leg of the bridal gear is joined to a shackle which in turn is linked to the OVLS winch wire leading to the forward port side winch. Schematic drawing of the two leg bridal gear and clump weight rigging arrangement is shown in Figure 2.

Figure 2: Schematic drawing of two leg bridal gear and rigging arrangement

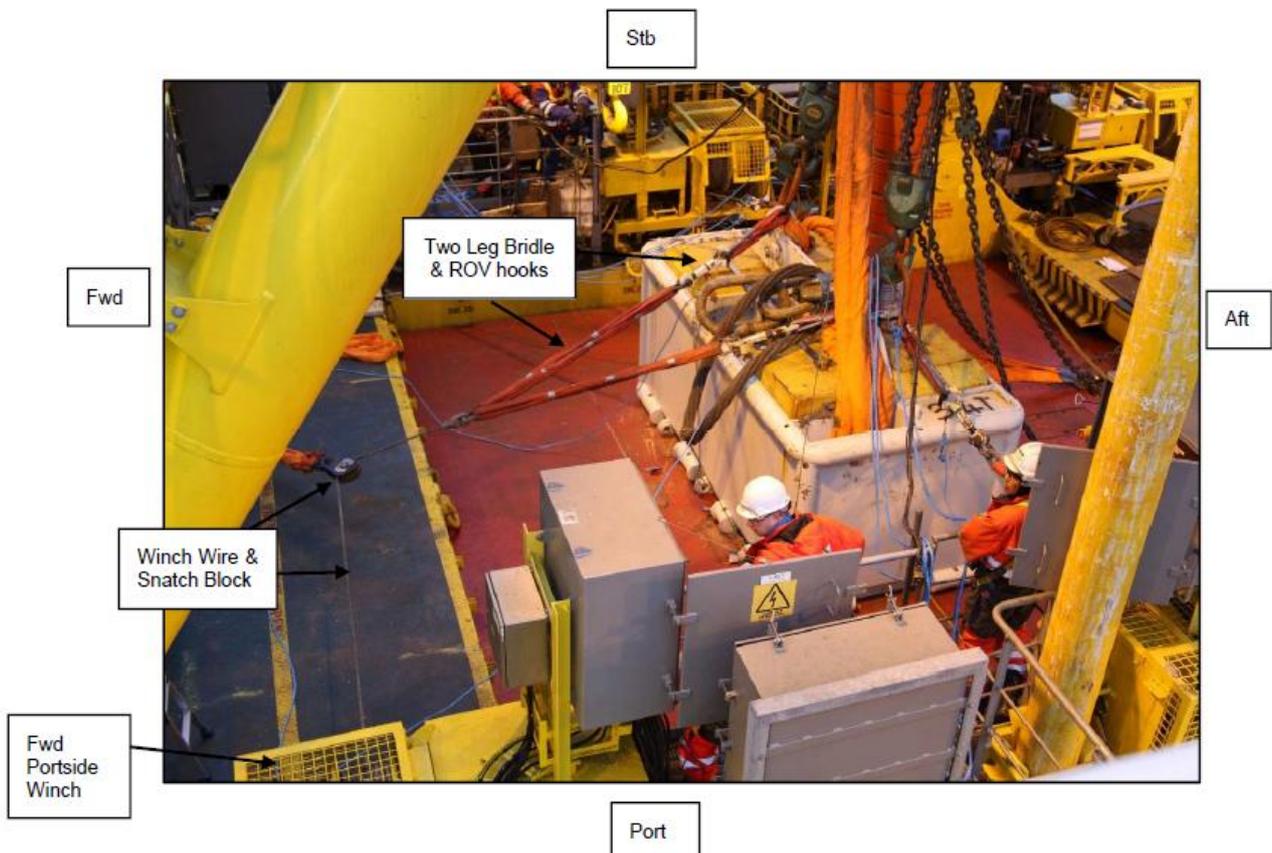
The riser and the clump weight are held in constant tension to control any untoward movement. This arrangement allows the lowering of the clump weight into the moon pool through the OVLS doors without making contact with the riser (Figure 3). A ‘management of change’ carried out prior to the accident had introduced changes in the operational procedure relating to the clump weight deployment.

Figure 3: Two leg bridal gear connected to the clump weight

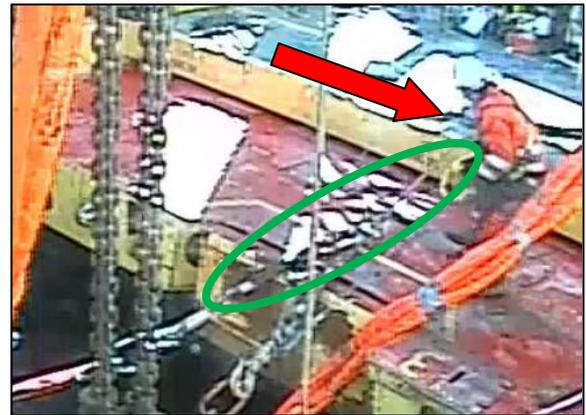
When the underside of the clump weight reached the sea level, the deck foreman briefly paused the operation. He instructed the forward port side winch operator to ease out the winch wire in order to release the bridal gear. The lead rigger approached the OVLS table and tugged on the messenger lines to disconnect the two hooks from the clump weight (Figure 4). Once released, the associated rigging was suspended over the edge of the forward OVLS door and into the area of the moon pool.

Figure 4: The lead rigger pulling on the messenger line to release bridal hook

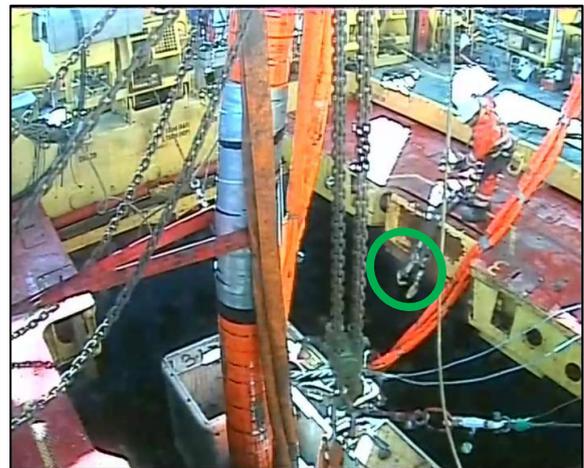
The deck foreman was positioned behind the forward port side winch operator and could directly observe the bridal gear and the lower lip of the OVLS table doors. Soon after, the deck foreman instructed the winch operator to hoist in the associated rigging. As the bridal gear came up, one of the hooks’ extension ‘beak’ snagged on the underside of the OVLS door (Figure 5).

Figure 5: Image showing the snagging of the hook and position of the lead rigger right above the area

At the time, the lead rigger was standing at the edge of the OVLS door, looking down into the moon pool (Figure 5). The bridal gear flung outward and struck the lead rigger’s left arm. The accident occurred at 1438 (LT) in position 60° 21.5’ N 004° 04.5’ W.

The immediate cause of the accident was the momentarily snagging of the hook and

uncontrolled release of the bridal gear under tension.

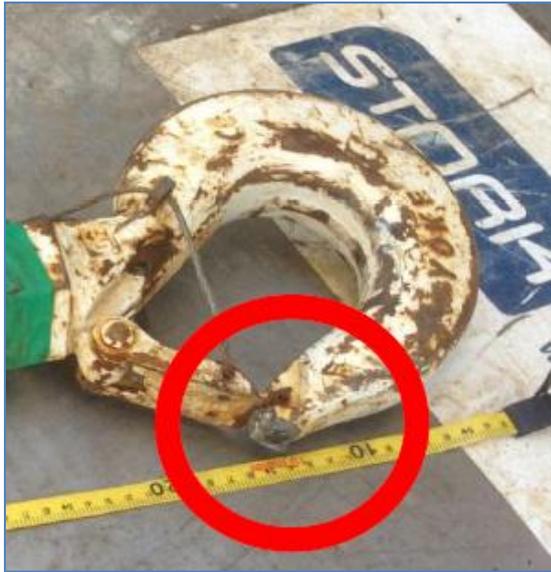
The bridal gear momentarily came under tension until the extension ‘beak’ broke away from the hook (Figure 6) and the entire bridal rigging was instantly freed with tremendous force.

Figure 6: Hook with damaged extension ‘beak’ after the accident

1. Safety information was issued for fleet wide distribution;
2. Snag potential assessments carried out in order to establish 'no go' snag back zones;
3. In consultation with the manufacturer, the ROV hook has been modified to remove the extension beak;
