SAFETY INVESTIGATION REPORT

REPORT NO.: 14/2016

MV SALUZI

**Fall over board of a pilot boat deckhand
In position 20° 39.14' N 106° 53.52' E
21 July 2015**

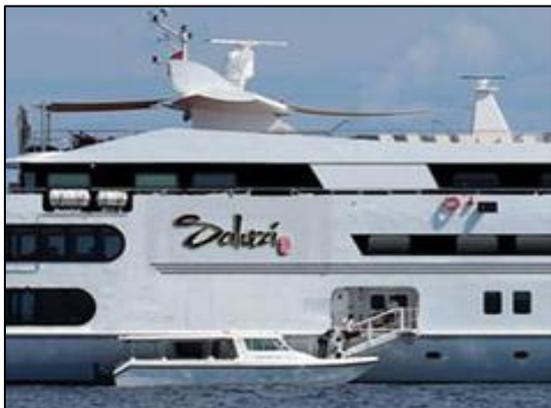
Figure 3: Position of starboard accommodation ladder

At about 1230 on 21 July 2015, *Saluzi* arrived at Haiphong, Vietnam. This was her first port of call in Vietnam. The draft on arrival was 2.40 m even keel. The harbour pilot requested a pilot ladder rigged on the port side. To this request, the master replied that the lack of parallel body would make the pilot ladder unsuitable for boarding. He advised using the starboard accommodation ladder (Figure 3) instead; a practice, which had been adopted by *Saluzi* for embarking pilots in other ports.

- A specific risk assessment was carried out for pilot transfer arrangement;
- In view of the inherent hazards in the use of the pilot ladder because of the specific shape of the hull, a permanent standing order has been issued by the master requiring that pilots only embark by the accommodation ladder. New arrival and departure checklists have been prepared;
- New instructions on the saving of voyage data have been issued and posted in close proximity of the VDR.

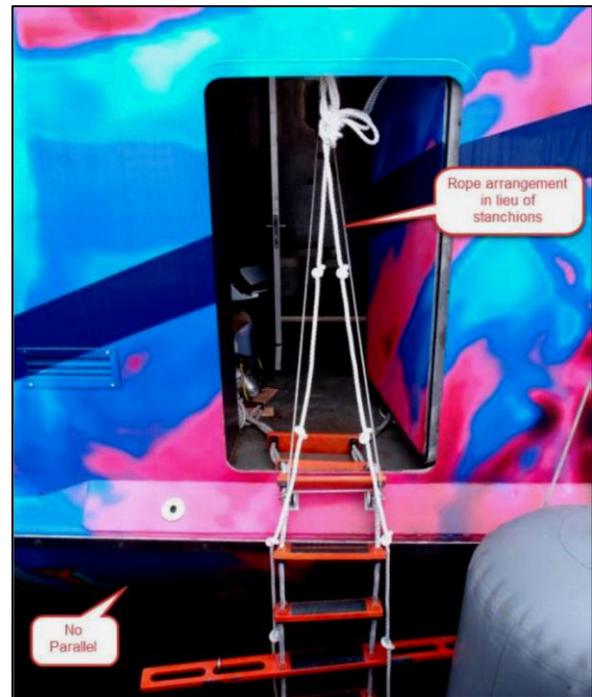
Figure 4: Pilot ladder on *Saluzi*

the pilot ladder in the hull opening, aft of the starboard accommodation ladder as shown in Figure 4.

- Pilot embarkation point was not within the midship half-length and parallel body of the ship hull;
- Rubbing band was in way of the pilot ladder;
- Curved hull prevented the steps resting firmly against the ship side; and
- There are no provisions for hand rails, stanchions or strong points at deck-level to fasten the pilot ladder.

- embarking pilots under the round hull near the ship's quarter;
- rigging of the pilot ladder in the cut-out access doors with limited space and view of embarkation operations;
- the effect of the swell on both the ship and the pilot boat; and
- the pilot boat getting caught on the rubbing band running along the side of the vessel.

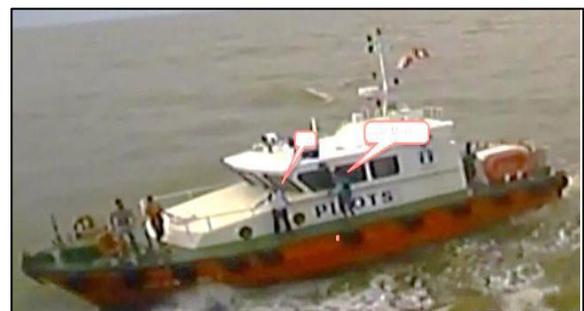
Figure 5: Pilot boat *Rang Dong 1*

The first two attempts to embark the pilot were unsuccessful. With *Saluzi* now heading 240°, a third attempt was made at 1315. An image captured by the ship's CCTV, showed five persons standing on the deck of the pilot boat *Rang Dong 1* (Figure 5), as she made her approach to come alongside *Saluzi*.

The CCTV image (Figure 5) showed that the pilot and the deckhand were already waiting on the inboard (port) side, *i.e.* the side closer to the ship. Based on available evidence, the safety investigation was unable to establish whether the risks had been analysed beforehand or whether it was a practice to wait on the inboard side of the pilot boat in preparation to board the vessel⁴.

It was also noticed that the fall overboard of the injured deck hand was indicative that he was not secured to a strong point on the pilot boat. It was considered to be very probable that this would have been seen as a restriction to operate with the necessary flexibility on board, given the prevailing sea

14/2016_R3 provide appropriate safety harnesses for use by deck hands;

14/2016_R4 ensure that pilot boat crew appreciates the importance of using the outboard route to access the pilot ladder;

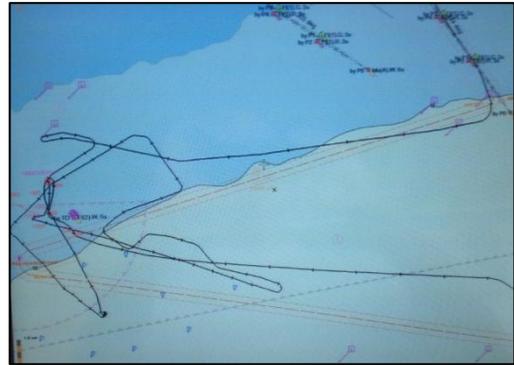
Figure 6: Intermittent search track by *Saluzi*

instructions to embark the pilot. After another attempt, the master was allowed to enter the channel without the pilot on board. Figure 6 shows *Saluzi's* intermittent search track at and around the pilot station.

Meanwhile, the pilot boat moved away and shortly afterwards, without communicating with *Saluzi*, it left the area. Seeing the pilot boat's abrupt departure and that no man overboard alert was raised by the boat's coxswain, the master concluded that the deckhand was recovered from the sea and he set course for the anchorage area. To this effect, the master relied on a negative communication loop.

14/2016_R5 promulgate procedures and action to initiate prompt search and rescue operations.
