SIMPLIFIED SAFETY INVESTIGATION REPORT

REPORT NO.: 09/2016

MV THOMSON CELBRATION **Serious injury to crew member** **during the launching of a tender boat** **10 June 2015**

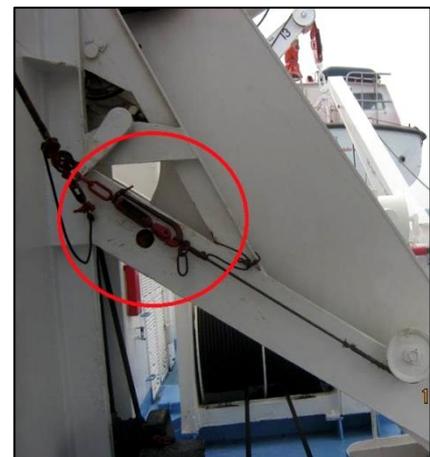
The accident happened when one of the ABs was unlashing the gripes on tender boat no. 15 (Figure 1).

Figure 1: The gripe being released by the AB at the time of the accident

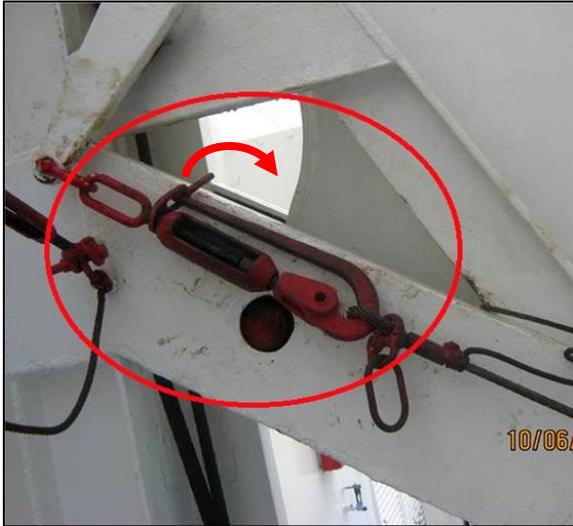
As he was removing the forward gripe wire rope, the pelican hook caught his finger as it swung open (Figure 2).

Figure 2: Details of the pelican hook

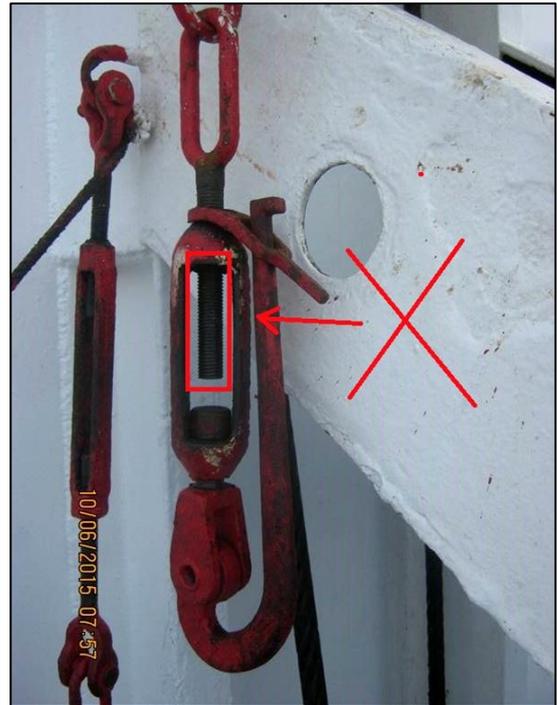
The release of the pelican hook is considered to be a simple operation and does not require any particular skill. In fact, the process entailed four sequential steps, as depicted in Figures 3-6. The first stage, the slacking of the wire rope (by means of the turnbuckle) is considered to be a critical one for the safe removal of the gripe (Figure 3).

Figure 3: Step 1 - The safe release of the gripe necessitates the slackening of the pelican hook

The opening of the pelican hook was sudden and violent. The severity of the injuries sustained by the AB was suggestive that the gripe had excessive tension stored in it because the turnbuckle on the hook was not released enough to relieve the tension (Figure 3). Consequently, the index finger was caught in the pelican hook lever (Figure 7).

The Company has ensured that safety briefings emphasise the importance of relieving the tension from the gripes before the safety ring on the pelican hook is released.

The Risk Assessment document has been amended and ‘Injury during lashing/unlashing’ has been inserted as a newly identified hazard. To address the risk, seven risk control factors were identified, *i.e.*:

1. Training;
2. Familiarisation;
3. Supervision;
4. Review of launching instructions;
5. Briefing before tendering;
6. Full release of turnbuckle and showing to supervisor before release; and
7. Use of appropriate PPE.

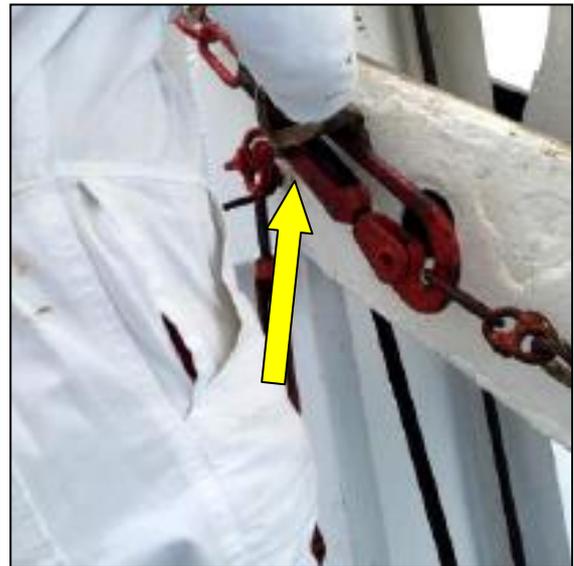
Figure 4: Step 2 - Removal of the pelican hook's securing ring

As already indicated, it was evident that the turnbuckle had not been fully released when the securing ring was being removed. Its release went unnoticed by the safety officer, leading to a ‘one person’ error situation.

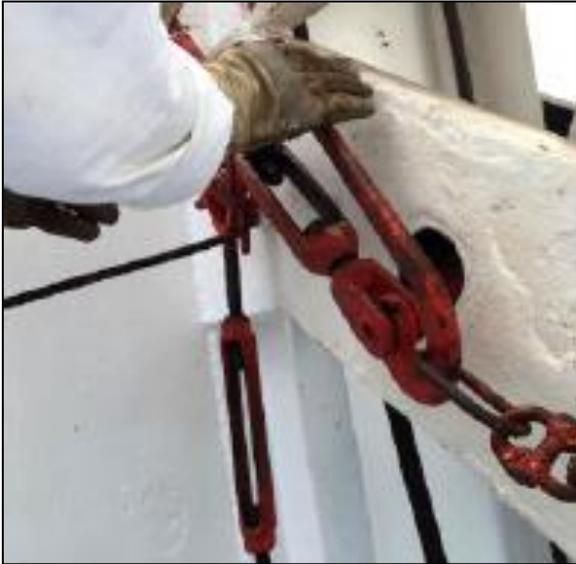
Figure 5: Step 3 - Opening of the pelican hook

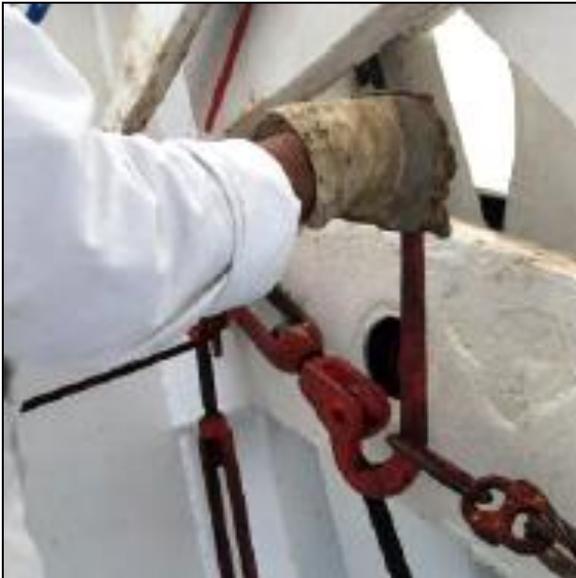
Figure 6: Step 4 – Release of the residual tension from the gripe

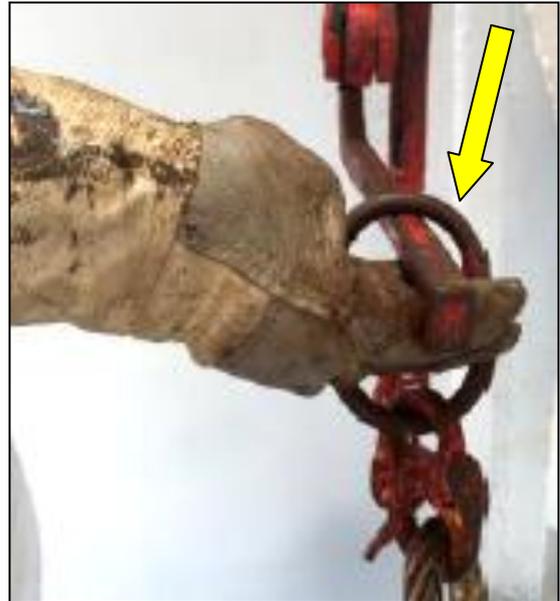
Figure 7: A reconstruction of how the index finger may have been injured by the pelican hook
