# REPORT

## MARINE 2016/06

## REPORT ON MARINE ACCIDENT - COLLISION BETWEEN STAR KVARVEN LAJK7 AND LULANYU 61809, 27 NOVEMBER 2014

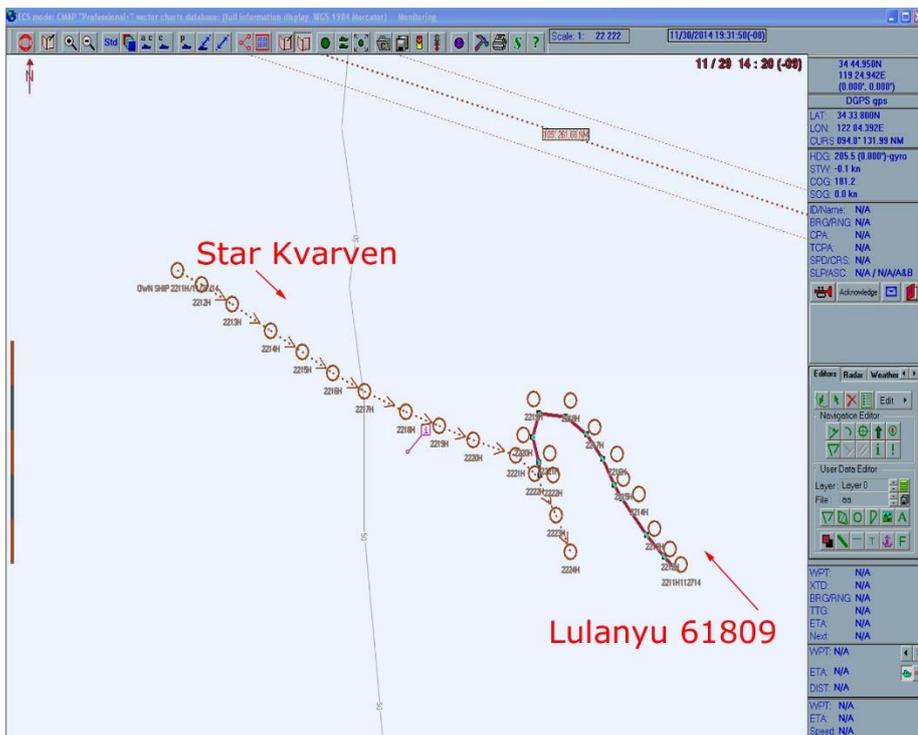
The AIS plot of the sequence of events shows that Lulanyu 61809 adjusted its course to starboard at around 22:13 (from 322° to 335°). From 22:16 onwards, the fishing boat adjusted its course to port several times (from 335° to 277°). At this point, the closest point of approach between the vessels was approximately 0.7 nm, until the fishing boat sharply changed its course to port at 22:18. At 22:20, Lulanyu 61809 had turned almost 180° from its original course.

Figure 3: AIS plot of Star Kvarven and Lulanyu 61809's pattern of movement. Source: Grieg Star AS.

The AIS plot shows that Lulanyu 61809, from 22:16, also started to adjust its course to port. The adjustment turned into a continuous turn to port, however, first slowly and then at an increasing speed, until the vessel, at 22:20, ended up on a course that was almost the complete opposite to its original course. The AIS plot shows that the most significant part of the turning manoeuvre took place at 22:18.

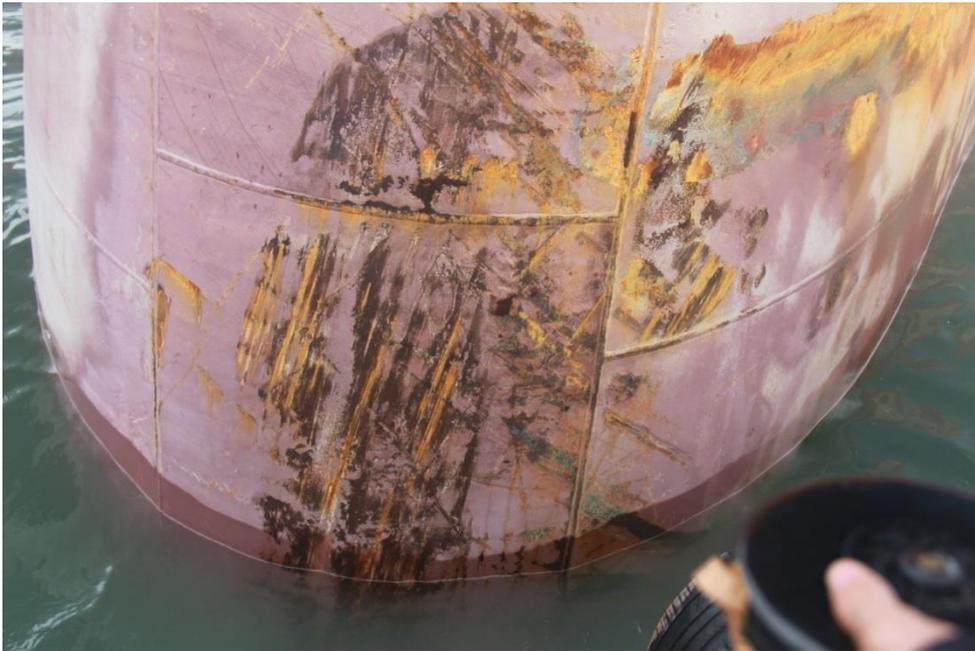
Star Kvarven sustained a 24 cm long and 7–10 cm deep indentation on the port side of the bulb, and the paint was scraped off in a contact area of 1.7x0.5 m; see Figure 4.

Figure 4: The photo shows the damage to Star Kvarven's bulb. Source: Jiangsu MSA / Grieg Shipping.
