REPORT

Marine 2016/08

MARINE ACCIDENT REPORT – B/W HAVFROST, SHIPBOARD OCCUPATIONAL ACCIDENT IN SINGAPORE 9 JUNE 2014

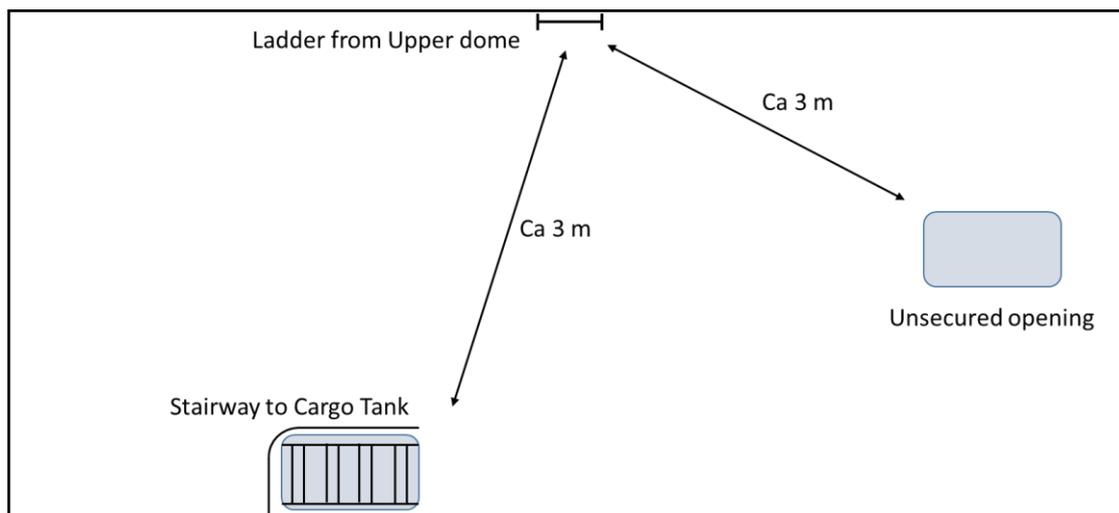
When the chief mate and deck trainee entered the tank, they found that no lighting had been set up inside. They therefore used their own lanterns. During the inspection, they found that a hatch cover had become dislodged from the deck in the lower tank dome and fallen to the bottom of the cargo tank, leaving the maintenance hatch¹ open and unsecured. The distance to the tank top was about 17 metres. They also found that the ventilation hose provided by the yard was coiled up on deck in the lower tank dome. The chief mate and trainee fed the end of the hose through the maintenance hatch to ensure that there was also ventilation inside the cargo tank itself.

Figure 4: Schematic diagram of the deck in the lower dome. Illustration: AIBN

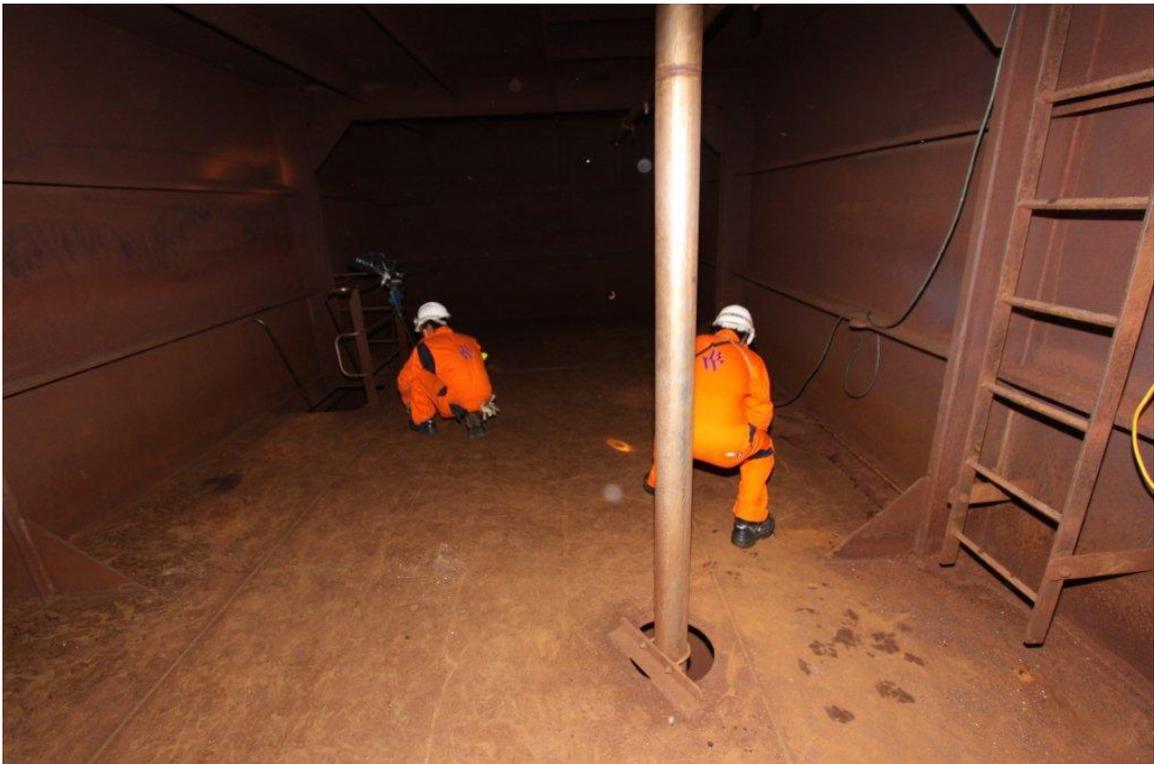
The bosun followed close behind. He looked around to locate the opening in the deck before he went over to the able seaman. No lighting had yet been rigged up in the tanks, but both men carried lanterns and felt comfortable that these would provide sufficient light for the time being. Both men were working on preparing the equipment, with their back to the entrance ladder: see Figure 5 below.

Figure 5: Photo from the lower dome. The approximate positions of the bosun and able seaman. Photo: Asker and Bærum Police

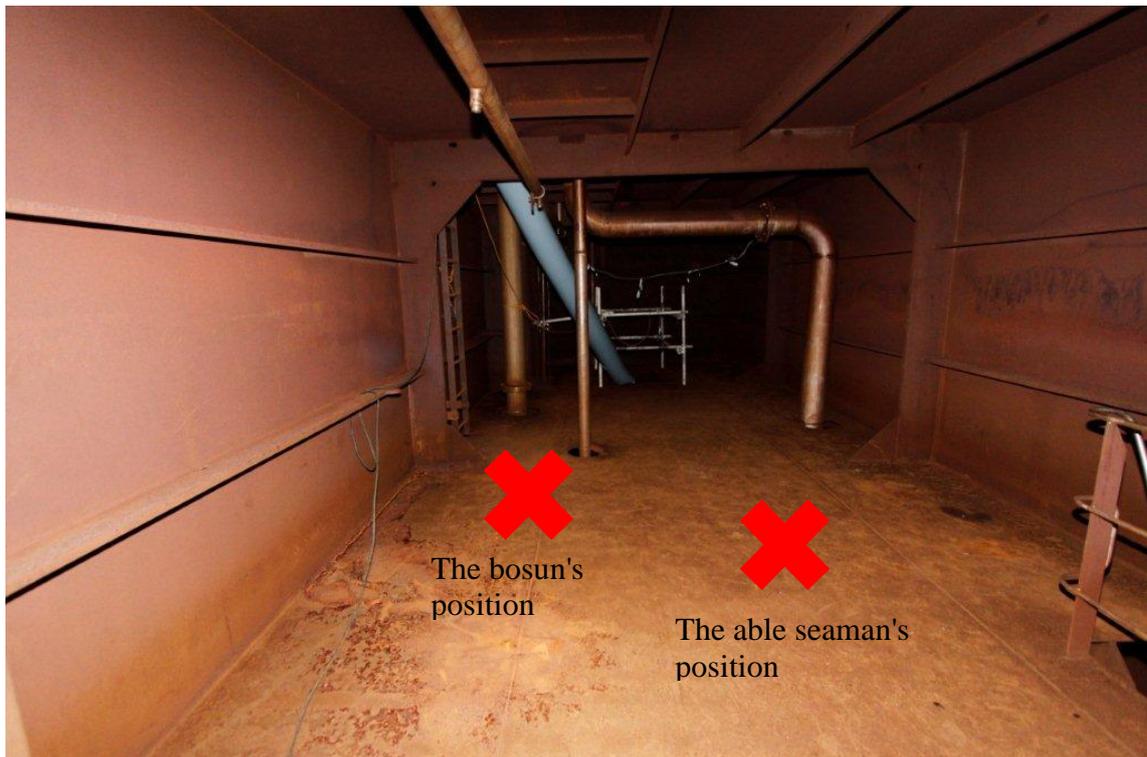
Figure 6: Photo from the lower dome. The unsecured opening can be seen at the far end. The guardrails were not in place at the time of the accident. The photo also shows the ventilation hose that had been fed into the tank through the unsecured open hatch. The red crosses indicate the approximate work positions of the bosun and able seaman. Photo: Asker and Bærum Police

- e) The AIBN finds that the lighting conditions in combination with the failure to place guardrails around the maintenance hatch were factors that contributed to the ordinary seaman's fall.

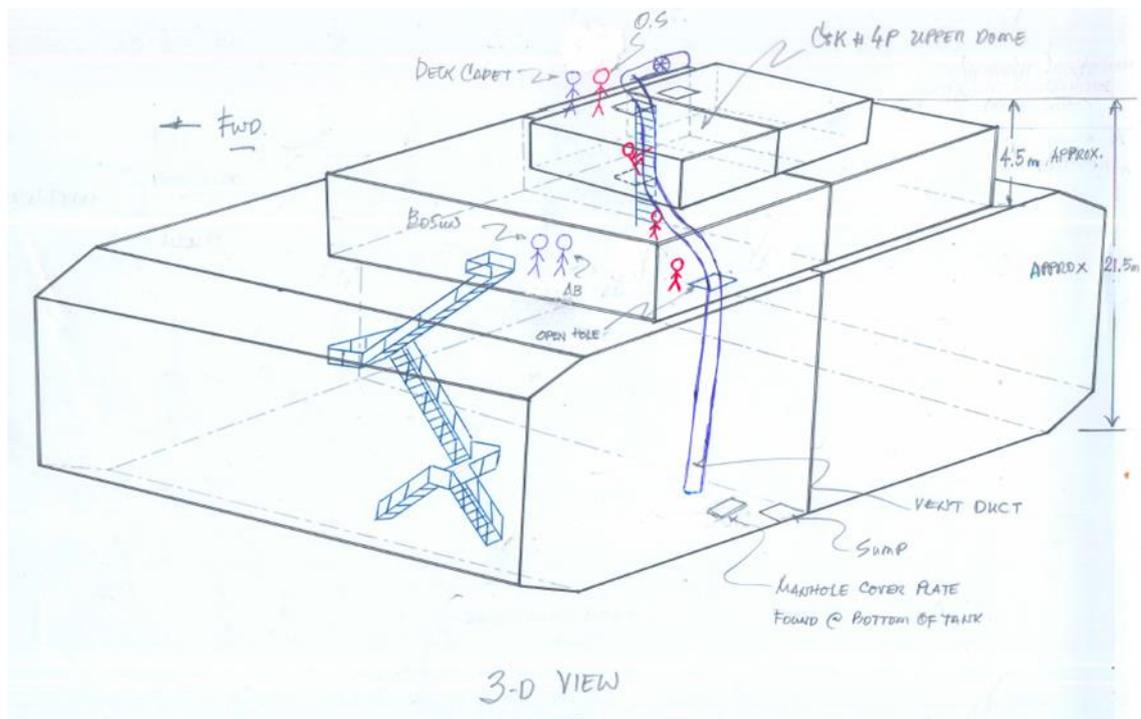
Figure 7: 3D drawing of cargo tanks 4S and 4P. The schematic diagram shows the positions and movements of the crew that were inside the tank at the time of the accident. Illustration: BW Havfrost
