Drowning of a passenger on *Pacific Dawn*

Coral Sea, South Pacific Ocean

9 November 2015

SUMMARY

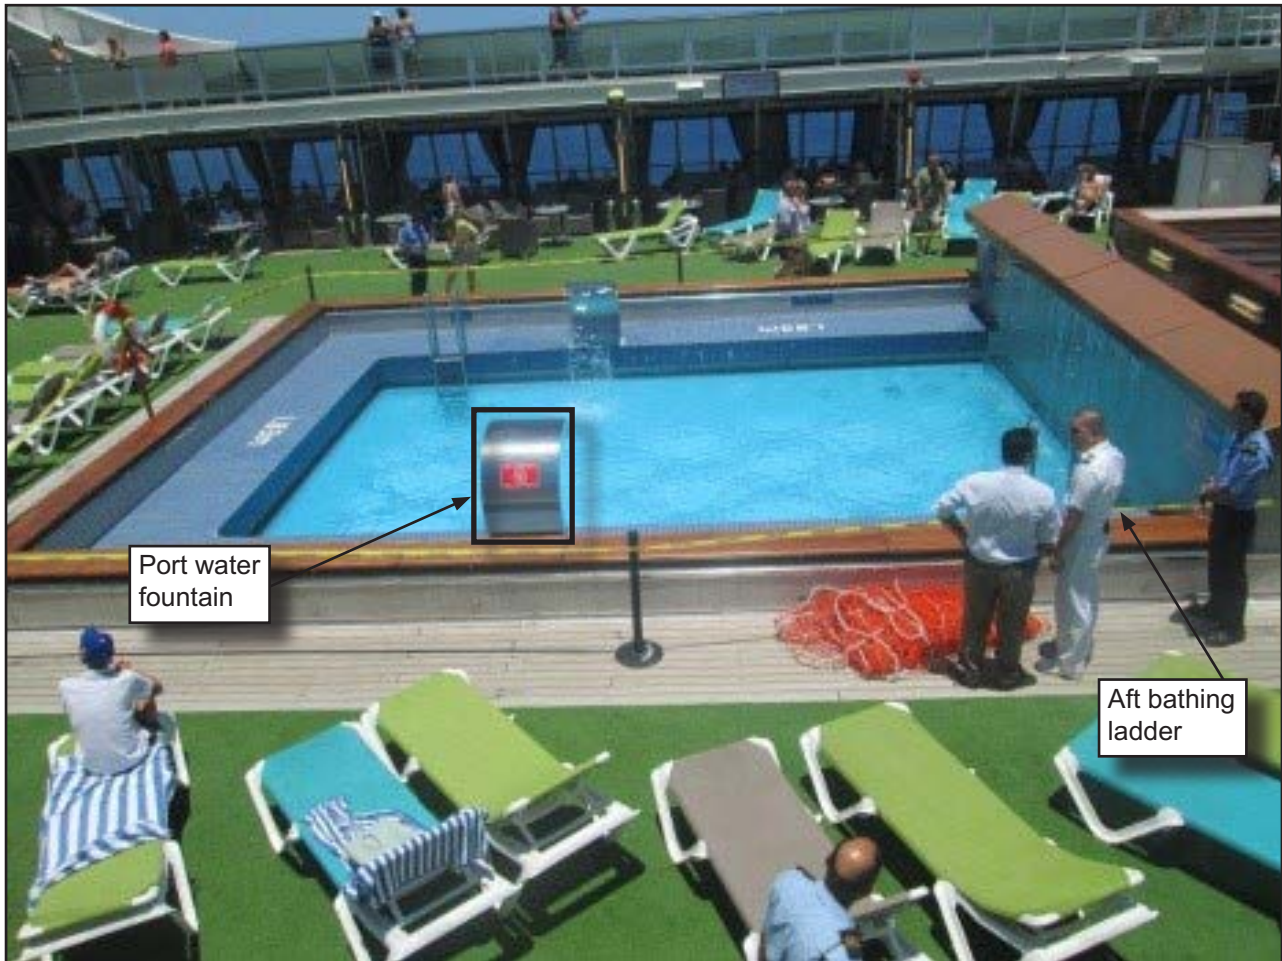
Figure 2 - Forward swimming pool viewed from port side

On the morning of 9 November, one of the passengers, Mr Oh, proceeded to the forward swimming pool on deck 12 (**Figure 2**). The ship's CCTV³ recording showed Mr Oh completing some brief stretching exercises before he entered the pool. At 1037, he slowly climbed down the pool's aft bathing ladder and entered the water. The pool's temperature was 30°C. He gently swam in the vicinity of the ladder and then moved under the port water fountain, allowing the water to flow over his head. He then swam away from the fountain for a longer period towards the centre of the pool before returning to the spot directly under the water fountain and, at one stage, appeared to briefly touch the side of the pool with his hand.

At this time there were at least four other passengers in the pool. At 1042, Mr Oh's head appeared to sink below the water and did not resurface. He then sank to the bottom of the pool unnoticed by the other pool users.

Although a security patrolman was on deck 14 looking down onto the pool area, he remained unaware that Mr Oh required assistance until another pool user raised the alarm approximately 10 minutes after Mr Oh had sunk below the water surface. While security patrolmen periodically provided a degree of swimming pool supervision, this accident demonstrates that the monitoring of passengers in a pool ideally needs to be provided on a constant basis to effectively identify and respond to a passenger in immediate risk of drowning.

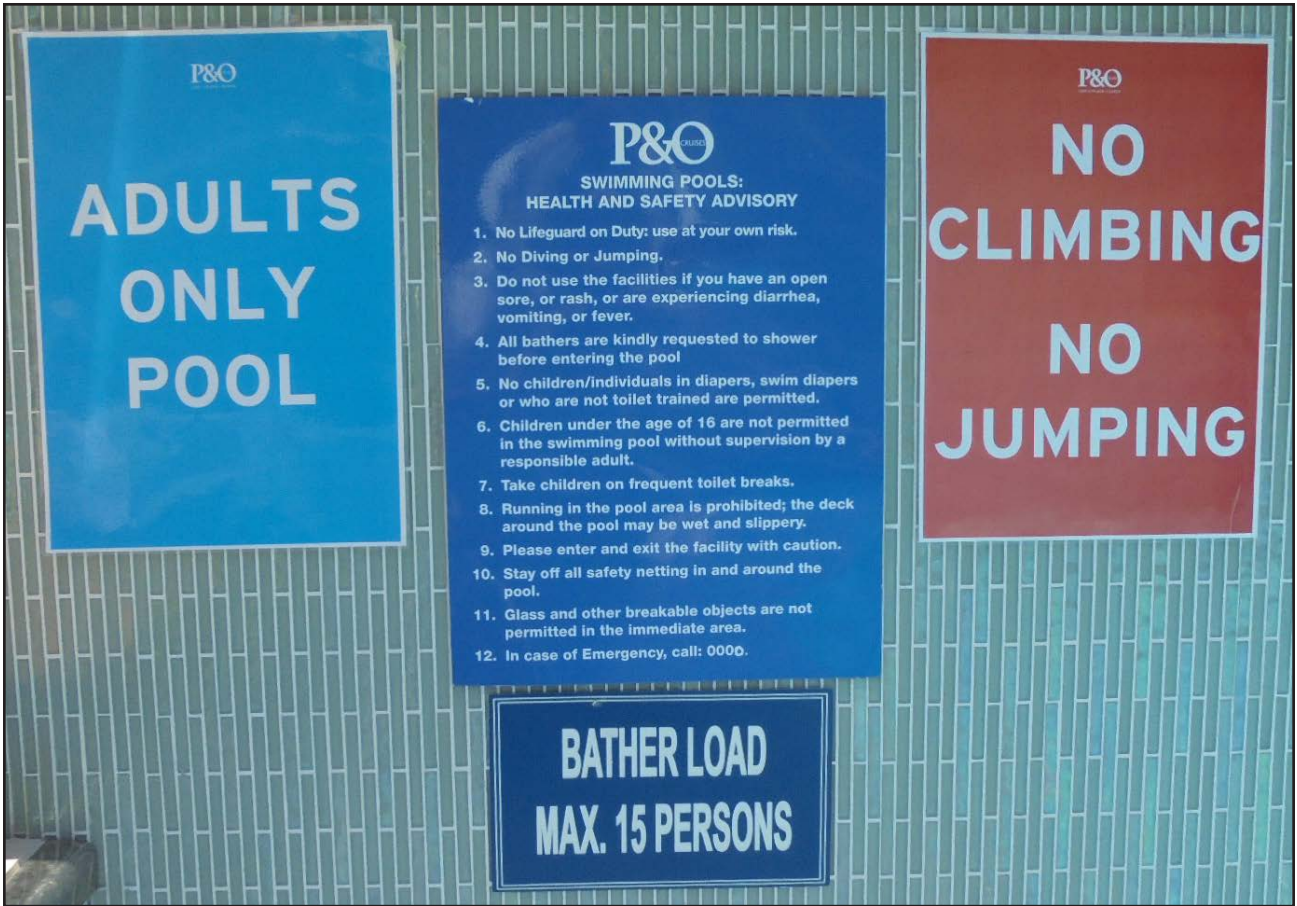
Figure 3 - Signage adjacent to forward swimming pool

Pacific Dawn had two swimming pools on deck 12. The forward pool was dedicated to adults only. Neither of the pools had designated attendants, and signage next to each pool stated that pool use was at the individual's risk (**Figure 3**). A sign indicating a bather limit of 15 was posted next to the pool. The depth of water in the pool was constant throughout at 1.83m, and this was indicated on the pool's side (**Figure 4**).

- updating its guest safety video to include pool safety information;
- providing flotation devices as an option for weaker swimmers;
- developing enhanced standard pool safety signs; and
- developing a pool safety guide for guests.

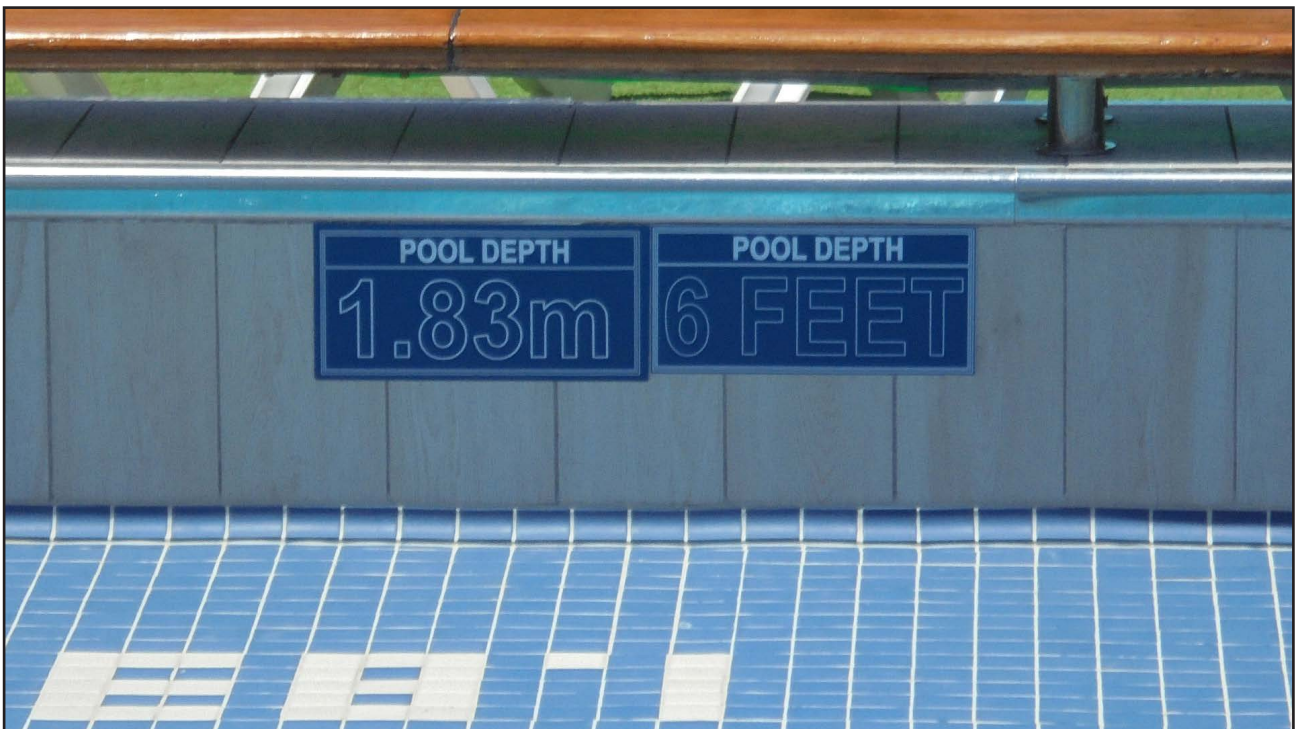
Figure 4 - Poolside indication of water depth

The HSE guidance on managing health and safety in swimming pools ashore strongly indicates that constant poolside supervision provides the best assurance of pool users' safety. However, it also recognises that a risk assessment may determine circumstances where the balance of cost and risk makes it possible to provide a safe swimming environment without constant poolside supervision. Many factors need to be considered. The guidance specifically recommends constant supervision if the water is deeper than 1.5m and if food and drink are available to pool users, both of which applied to the forward swimming pool on board *Pacific Dawn*.
