TECHNICAL ALERT No.16-38

TALON II Lifeboat On Load Release Systems

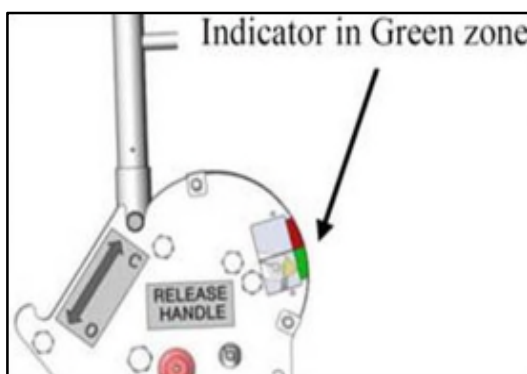
Picture 1 – Makers Manual

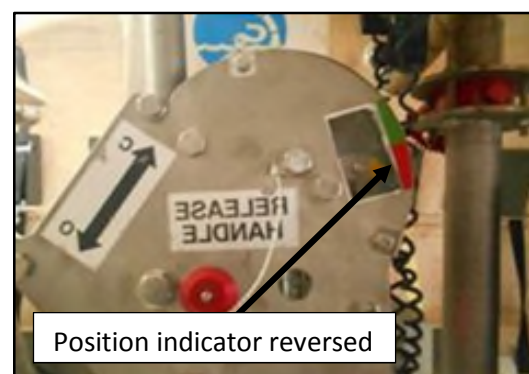
- 2.1. The ship's lifeboats had been "re-hooked" for compliance with SOLAS III/1.5 and MSC.1/Circ.1392 18 months prior to the detention.
- 2.2. As per the makers manual, when the hook and the hydrostatic interlock are correctly reset the interlock indicator on the release mechanism should point to the green sector of the position indicator markings as shown in Picture 1.
- 2.3. During PSC inspection of the vessel it was noted that the position indicator markings for the hydrostatic interlock were incorrectly marked with the red and green sectors being reversed as shown in Picture 2.

Picture 2 – As found on board

- 2.4. The LSA code states *“If colour coding is used, green shall indicate a properly reset hook and red shall indicate danger of improper or incorrect setting”*. In this case the improper marking could potentially have led to improper resetting or operation of the on load release system.

- 2.5. PSC made the decision to detain the vessel based on the incorrect marking of the hydrostatic interlock indicators.
- 2.6. Investigation of this detention by the Bahamas Maritime Authority (BMA), in consultation with the ship owners, type approval body and manufacturer, has identified that the incorrect marking of the interlock position indicator markings occurred during manufacture of the on load release system.

- 3.1. Owners of Bahamian ships with lifeboats fitted with Hyundai Lifeboat TALON II 4.0, 6.0 or 9.0 on load release hooks should inspect the hydrostatic interlock position indicator markings on the release mechanisms installed in their lifeboats to ensure that they are correctly marked as per the manufacturer’s instructions.

- 3.2. Where markings are found to be incorrect the Recognised Organisation issuing the ships statutory certification and the BMA are to be advised. The manufacturers are also to be contacted in order to arrange for the defect to be rectified.
