SAFETY INVESTIGATION REPORT

REPORT NO.: 08/2016

May 2016

MV Kadri Fatal injury to a crew member at Tallinn Shipyard 19 May 2015

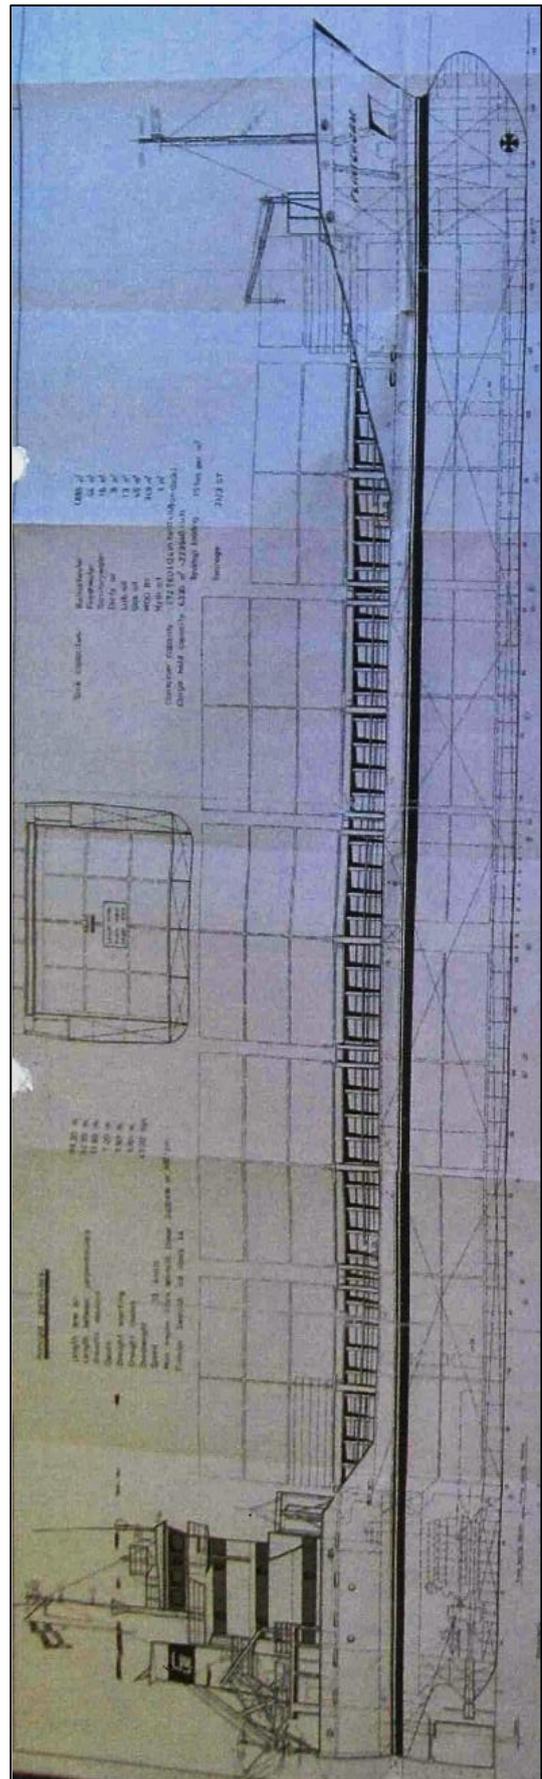
Figure 1: *Kadri* GA Plan

The vessel has a length overall of 99.86 m. She has one cargo compartment with a number of lift on / lift off hatch covers for the stowage of containers. With a deadweight of 4506 tonnes, she is capable of carrying 148 TEU on deck and 124 TEU in the cargo hold (Figure 1).
