SAFETY INVESTIGATION REPORT

REPORT NO.: 14/2016

MV SALUZI

**Fall over board of a pilot boat deckhand
In position 20° 39.14' N 106° 53.52' E
21 July 2015**

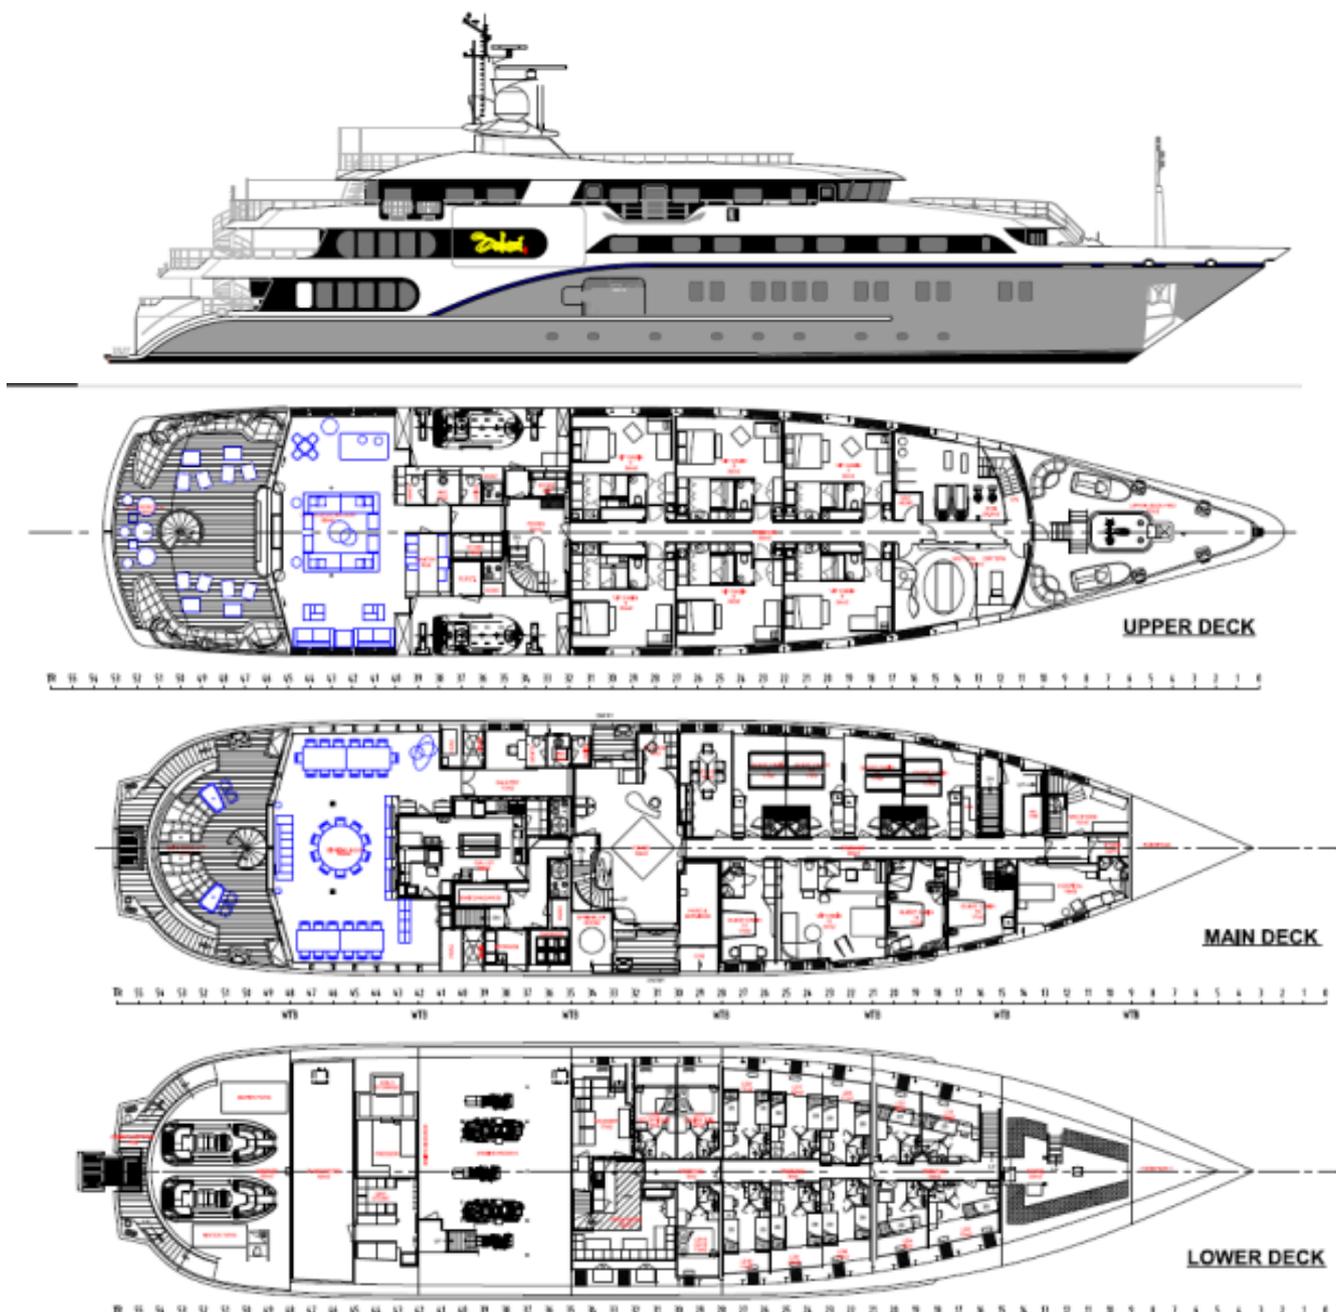
Figure 1: MV *Saluzi* GA Plan

Saluzi (Figure 1) was designed and built by the Austal Shipyard, Henderson, Australia in 2003. The hull and superstructure are constructed of aluminium. The vessel is owned by Falkenberg Investments Ltd., Hong Kong and managed by V Ships Leisure SAM, Monaco. She is classed with Bureau Veritas. *Saluzi* has a length overall of 69.10 m, a moulded breadth of 13.80 m and a moulded depth of 4.80 m.
