REPORT

Marine 2016/08

MARINE ACCIDENT REPORT – B/W HAVFROST, SHIPBOARD OCCUPATIONAL ACCIDENT IN SINGAPORE 9 JUNE 2014

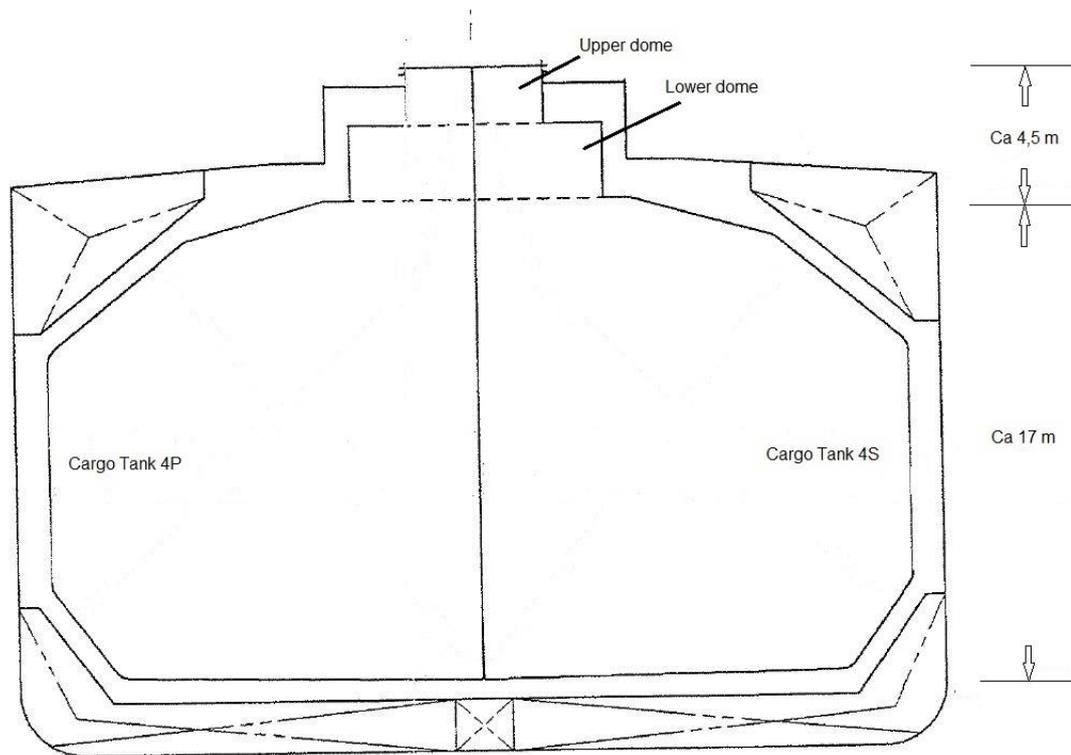
Figure 3: Schematic diagram of the vessel's cross-section at cargo tank no 4. Source: Drawing provided by BW Havfrost and edited by the AIBN

When the chief mate and deck trainee entered the tank, they found that no lighting had been set up inside. They therefore used their own lanterns. During the inspection, they found that a hatch cover had become dislodged from the deck in the lower tank dome and fallen to the bottom of the cargo tank, leaving the maintenance hatch¹ open and unsecured. The distance to the tank top was about 17 metres. They also found that the ventilation hose provided by the yard was coiled up on deck in the lower tank dome. The chief mate and trainee fed the end of the hose through the maintenance hatch to ensure that there was also ventilation inside the cargo tank itself.
