Drowning of a passenger on *Pacific Dawn*

Coral Sea, South Pacific Ocean

9 November 2015

SUMMARY

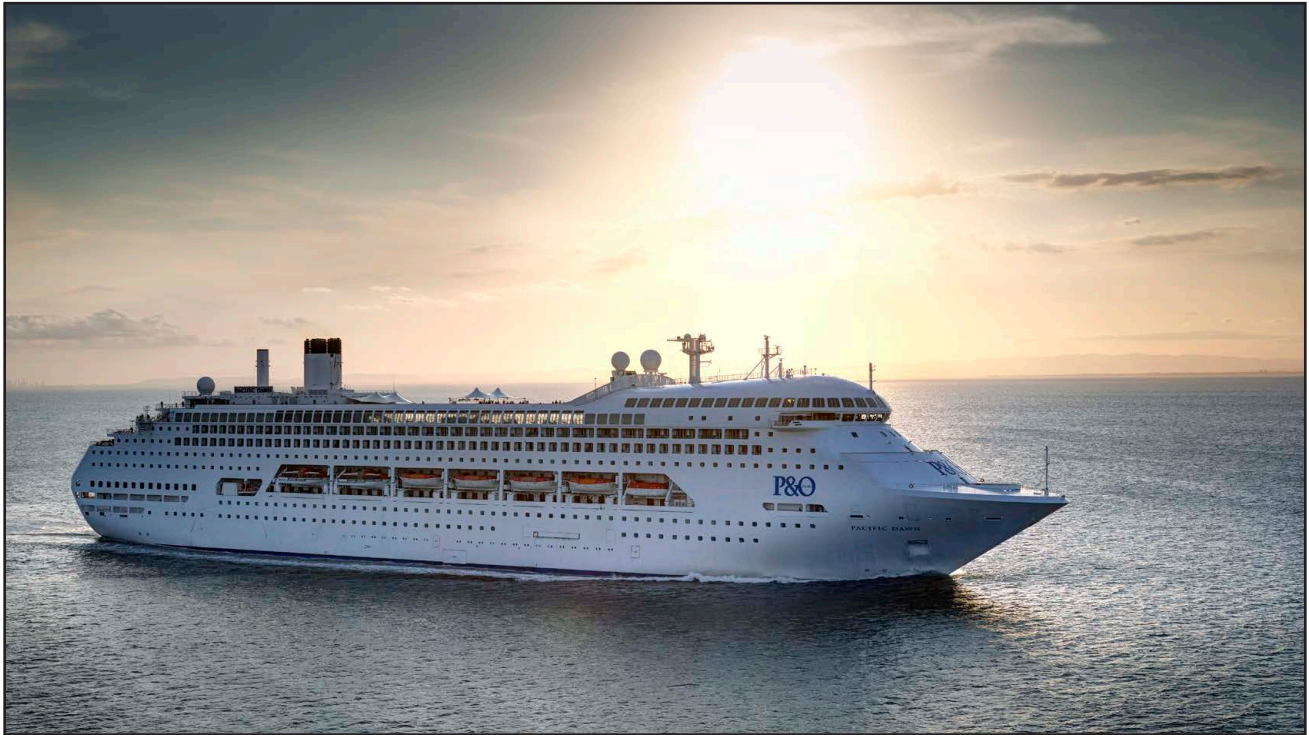
Figure 1 - Pacific Dawn

During the evening of 7 November 2015, *Pacific Dawn* (**Figure 1**) commenced a 10-night cruise from Brisbane, Australia to the islands of Papua New Guinea. The first port of call was Alotau, where the vessel was scheduled to arrive on 10 November.
